ORANGEREPORT

PROCESSING INDUSTRY

Metal Contaminants Test Mettle of Specialty Paper Products Manufacturer

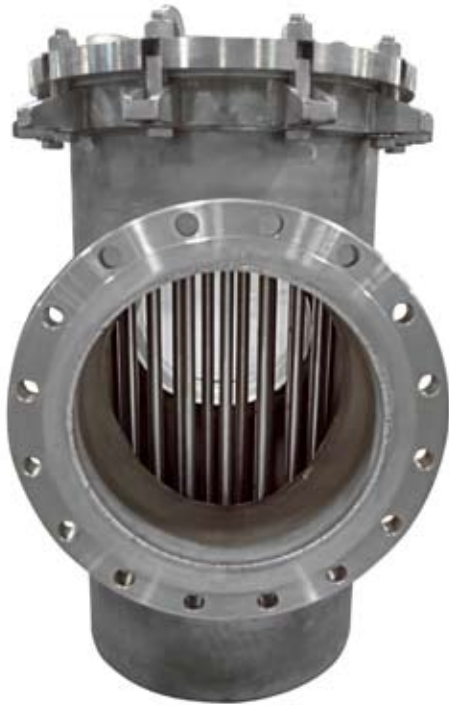
MODEL T FERROUS TRAP

Ahlstrom ordered [Model T Magnetic Traps](#) from Eriez®. T-Traps remove ferrous contamination in 6 to 36 in. (152-914mm) pipelines. They feature rugged welded pipe and reinforced plate construction and withstand working pressures up to 75psi. (5.3kg/sq cm) in standard models.

Since installing Eriez T-Traps, Ahlstrom reports that there has been a significant amount of metallic product trapped before going to the refiners, therefore, cutting down on damage to the equipment and helping ensure product quality. Issues that were once a regular occurrence are now a thing of the past.
